VEHICLE SNAPSHOT

1967 Ford Mustang Coupe

Deep teal / black vinyl | 289 V8 / 4-speed manual | Classic vehicle record

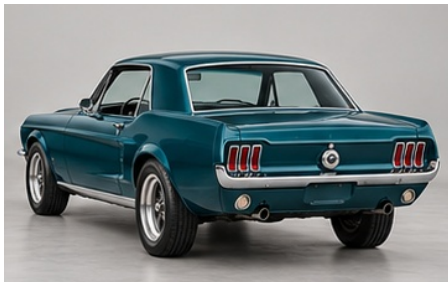
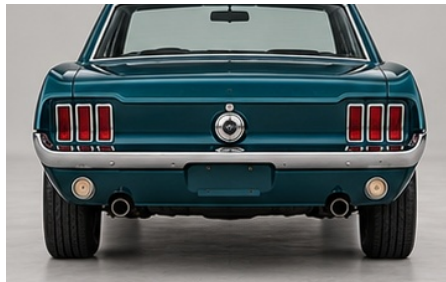
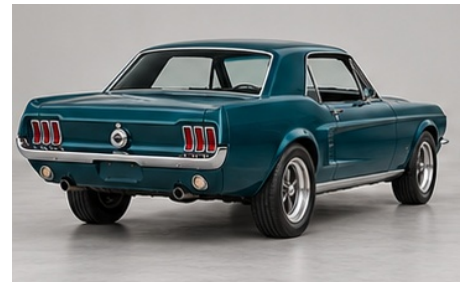
Light chrome pitting at the rear bumper corner. Cosmetic in the supplied views; retained as the single customer minor note. E05-E07.

| PRIORITY | RECOMMENDED ACTION | REFERENCE |
|---|---|---|
| Optional cosmetic care | Monitor rear trim pitting; address during routine detailing or trim restoration. | F04 / E05-E07 |

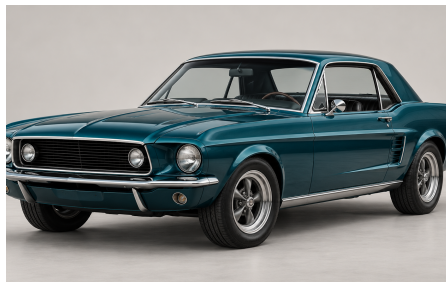
E01 Front-left / cover view

Isolated finish chip at lower leading edge. Exposed substrate is visible; no spreading corrosion is established by these images. E01 + S02.

Suggested care: Obtain a close-range inspection of the chipped edge, protect exposed material and agree a proportionate touch-up plan. Avoid interpreting a clean photograph as a structural or accident-history clearance.

| PRIORITY | RECOMMENDED ACTION | REFERENCE |
|---|---|---|
| Preservation | Inspect and protect the left-front paint chip; agree a local finish repair if appropriate. | F01 / E01 / S02 |

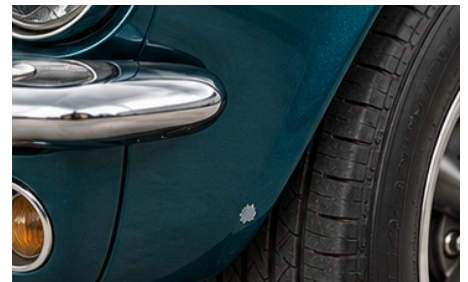
S02 Left-front finish detail

Exterior views accepted for coverage, focus and framing. F01 is retained for local finish repair assessment; F04 records limited chrome pitting. Reflection patterns are consistent in the supplied overview views, but do not prove the absence of prior repairs, filler or concealed corrosion. Paint thickness was not measured.

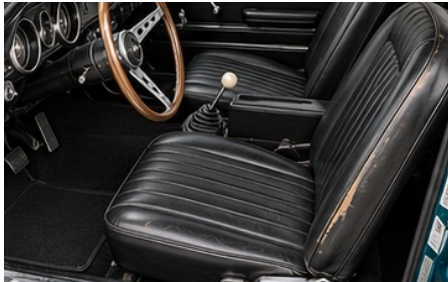
E09 Driver door / front cabin

Localized seam wear and vinyl creasing. Cushion support and seat structure require hands-on assessment. E09 + S03.

| PRIORITY | RECOMMENDED ACTION | REFERENCE |
|---|---|---|
| Planned cosmetic care | Assess driver bolster seam wear with an upholstery specialist. | F02 / E09 / S03 |

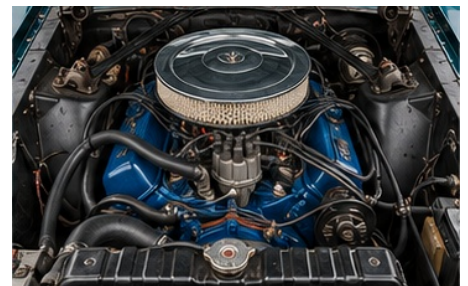
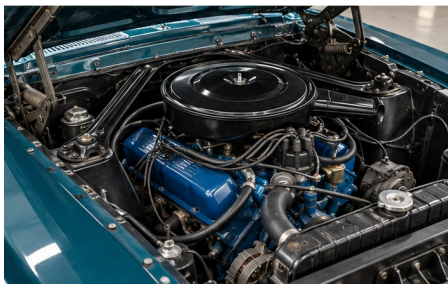
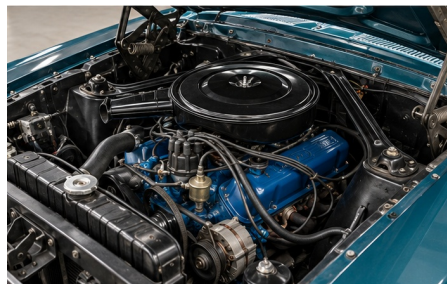
Surface age cracking visible on an accessible hose section. Arrange a cold-engine technician inspection before extended use. E14-E16 + S04.

| REVIEWED OBSERVATION | INTERPRETATION / LIMIT |
|---|---|
| F03 hose condition retained for inspection | Cold-engine technician assessment recommended |

| PRIORITY | RECOMMENDED ACTION | REFERENCE |
|---|---|---|
| Before extended driving | Have a technician inspect the aged hose area with the engine cold; renew affected material as advised. | F03 / E14-E16 / S04 |
