VEHICLE SNAPSHOT

1967 Ford Mustang Coupe

Deep teal / black vinyl | 289 V8 / 4-speed manual | Classic vehicle record

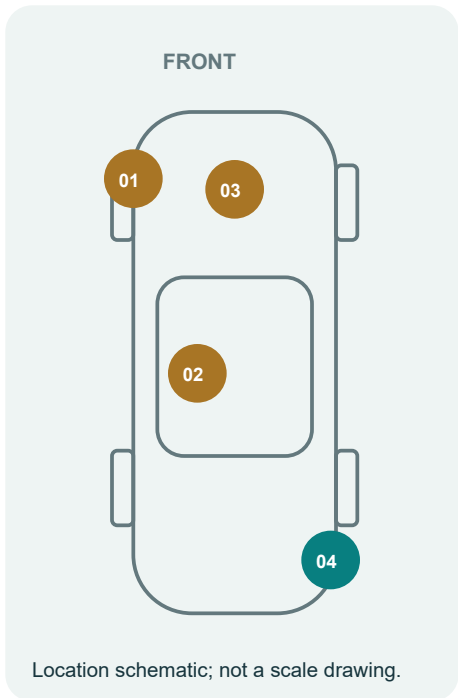
**F01 Left-front fender**

Isolated finish chip at lower leading edge. Exposed substrate is visible; no spreading corrosion is established by these images. E01 + S02.

| PRIORITY | RECOMMENDED ACTION | REFERENCE |
|---|---|---|
| Preservation | Inspect and protect the left-front paint chip; agree a local finish repair if appropriate. | F01 / E01 / S02 |
